# FALLER HOUSE

COUPEVILLE, WASHINGTON

## HISTORIC STRUCTURES REPORT

Published June 10, 2014.

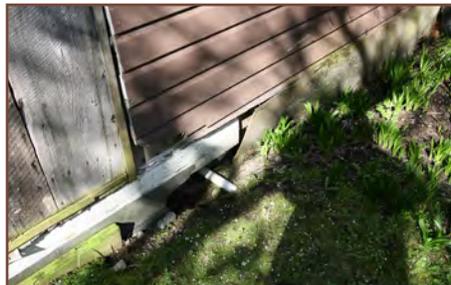
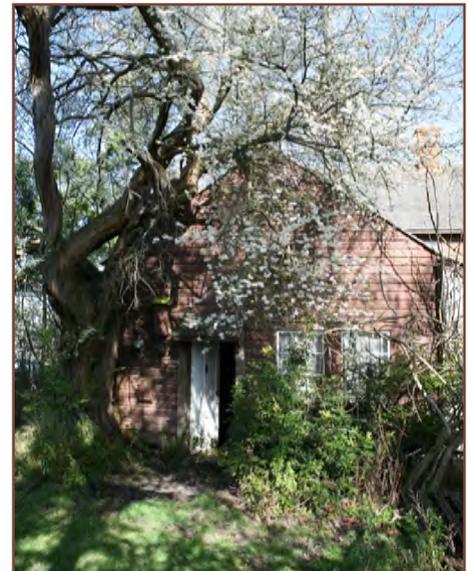
- Overall in poor condition
- Due to the site's sloped grade surface storm water flows beneath the house from south to north.

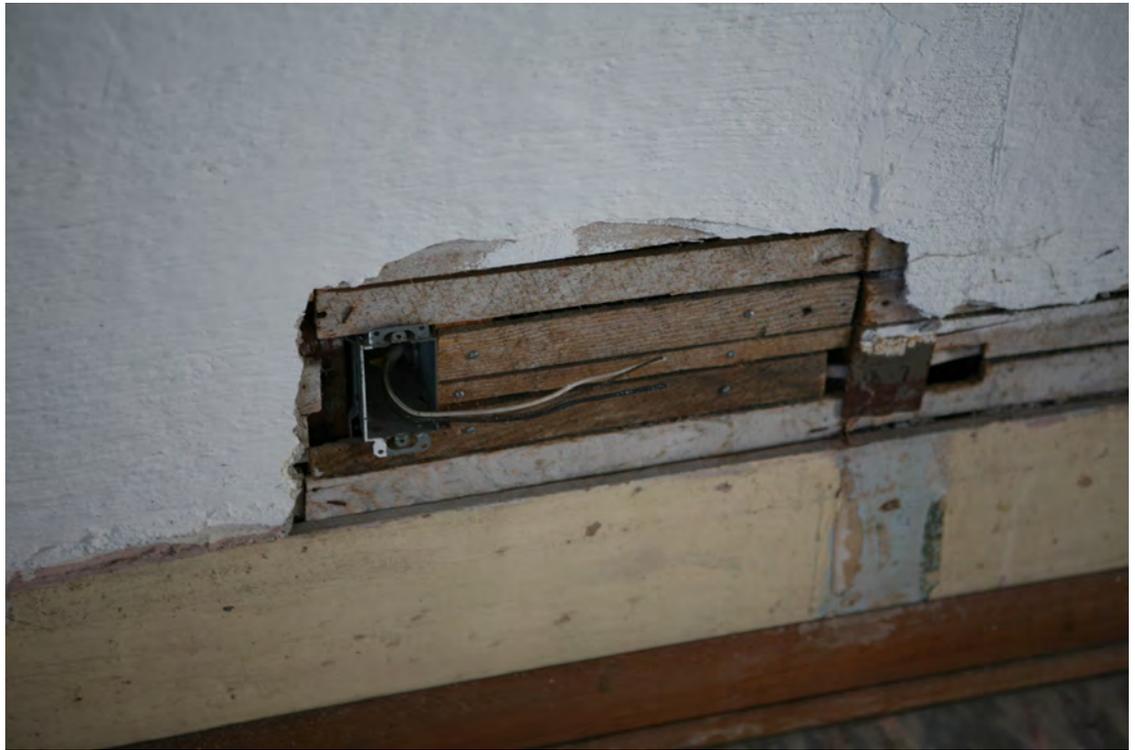
CP 2. 1866 portion, first floor, east room. Detail of baseboard and openings cut in plaster for wiring. Source: Artifacts Consulting, Inc.

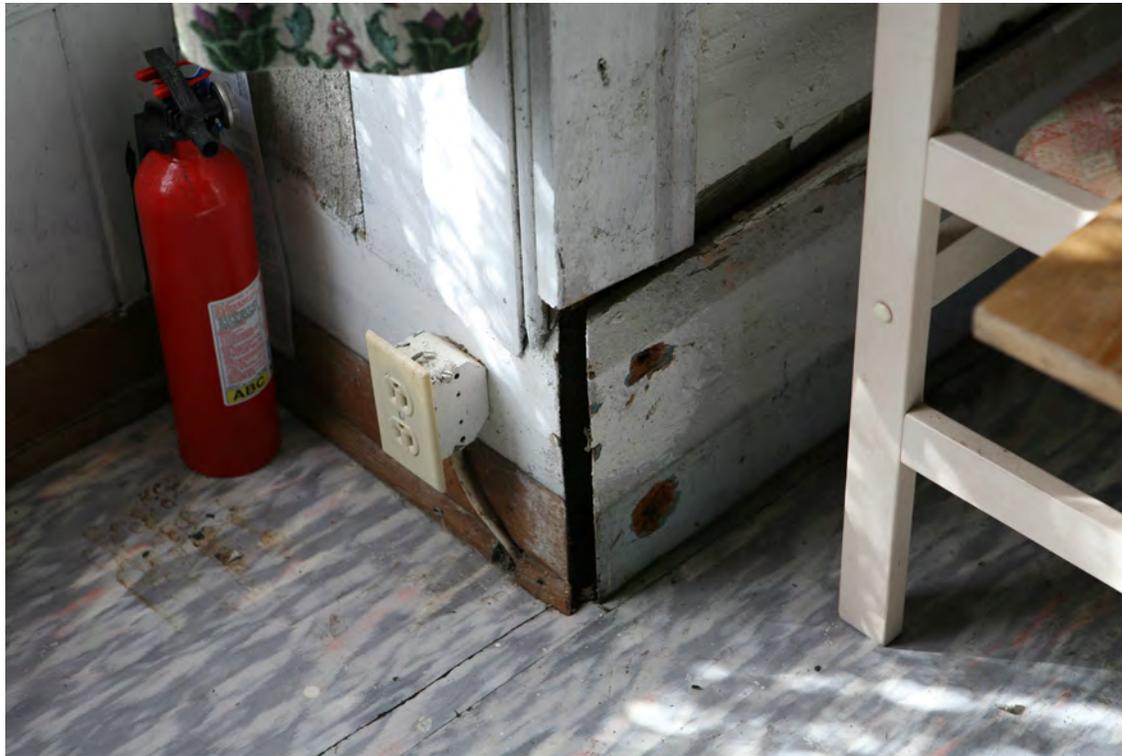
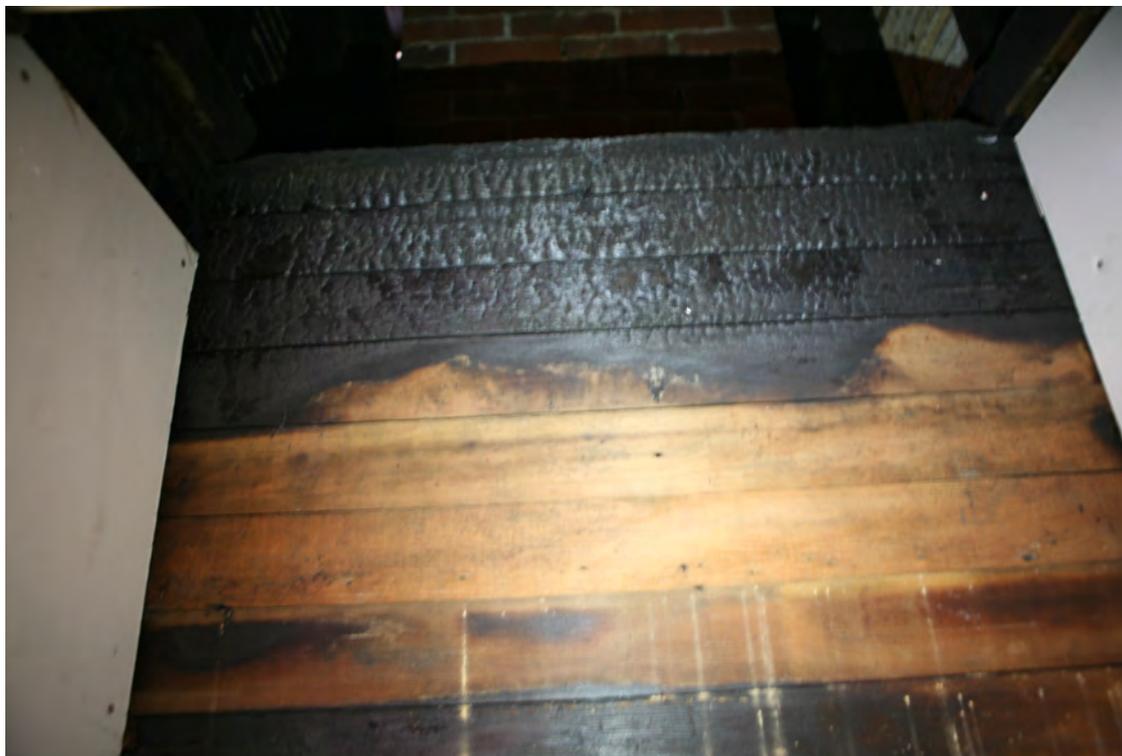
CP 4. Fire damage along back wall of closet. Source: Artifacts Consulting, CP 3. 1866 portion, first floor, east room, baseboard detail. Source: Artifacts Consulting, Inc.

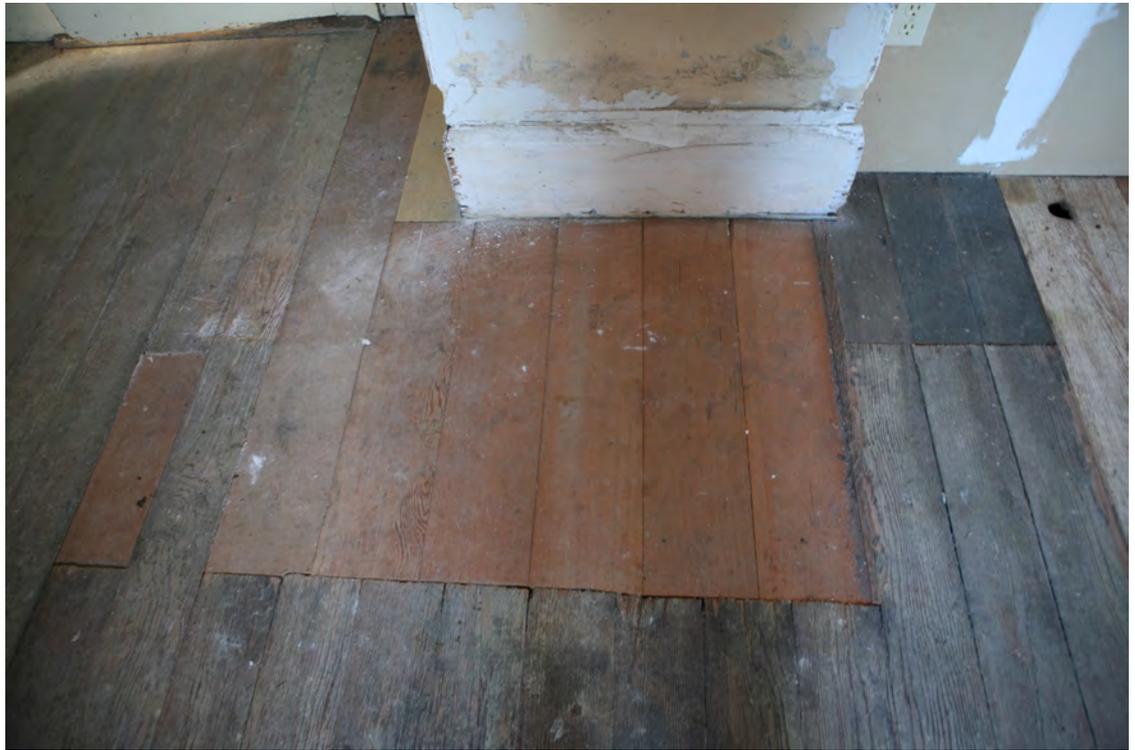
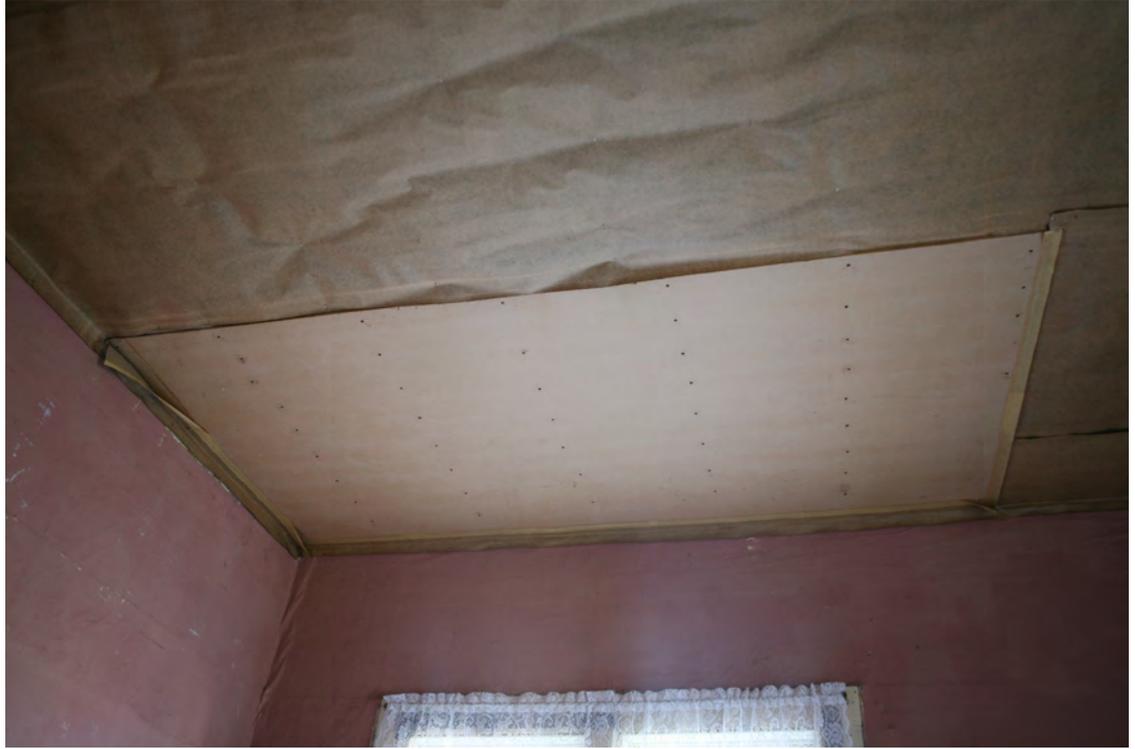
CP 8. Floor repair adjacent chimney. Source: Artifacts Consulting, Inc. CP 7. Ceiling missing plaster. Source: Artifacts Consulting, Inc.
