# FALLER HOUSE

COUPEVILLE, WASHINGTON

## HISTORIC STRUCTURES REPORT

Published June 10, 2014.

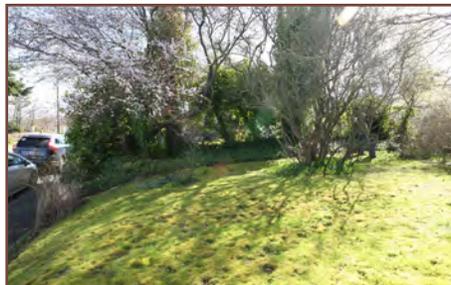
- Within the yards there appear to be no additions of more contemporary vintage plantings (for example, no purple-leaved foliage - fashionable from the 1970s onwards, no Japanese Maples or Azaleas - fashionable from the 1940s onwards), no Junipers or Mugo Pines (fashionable from the 1950s and 1960s onwards), no Day-lilies, Hellebores, Bunchgrasses, Sedges, or hybrid Hydrangeas- the contemporary vogue in domestic yards.
- Deferred pruning of trees and shrubs within the site.
- Deferred weeding within the planting beds

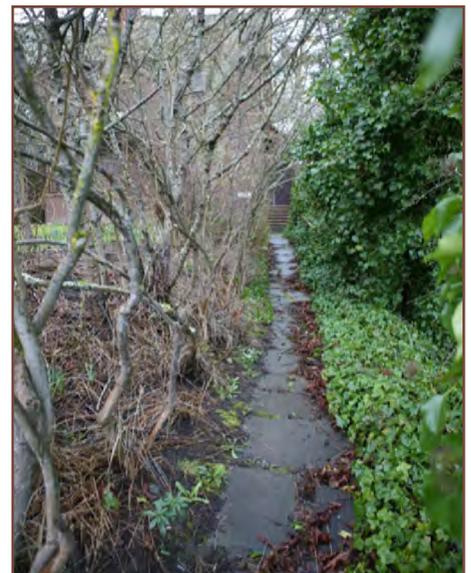
- The Haller House yards have numerous seedlings plum trees - probably offspring of the historic tree.
- Extensive English Ivy growth encroaches on the landscape and has grown up into several of the trees.
- Uneven settlement in the concrete walkway leading from the north and west entrances to the sidewalk.
- An added contemporary fence along the north, east and most of the west side, consisting of rectangular sheep wire supported on metal fencing posts.
- Contemporary concrete sidewalk to the entry through the west side of the site
- Contemporary fire hydrant in the northwest corner of the site.
- Foundation remnants in the northwest corner of the site from the former store building (which became a cinema) demolished in 1954
- Concrete retaining wall along the south side of the site

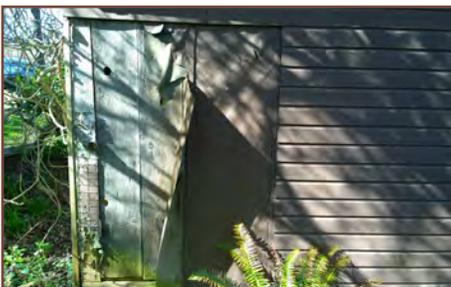
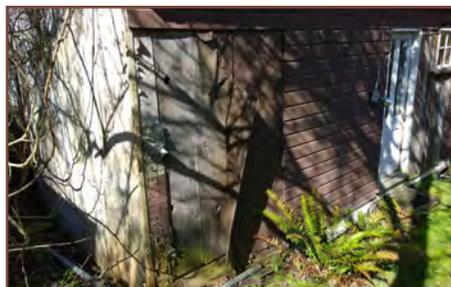
- Overall fair condition
- Exposed sections of vertical planking along the south portion of the east facade

- Added contemporary wall sconce on the south facade
- Added shed roof canopy and casings at the south entrance
- Enclosure of southeast porch. By the 1930s this porch had been enclosed, the existing enclosure however is contemporary and replaced the previous enclosure materials

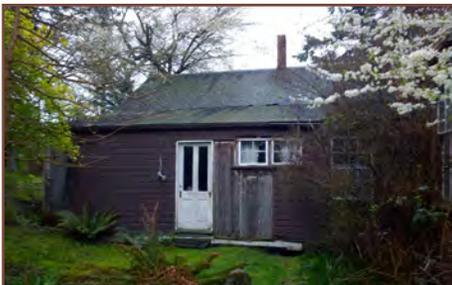
- Overall poor condition
- Water enters through the top of the chimney penetrating to the building interior
- A hole in the west slope at the south end of the roof allows water into the attic and ceiling framing
- Biological growth on the wood shingles
- Damaged gutter on the east addition shed roof that spills water against the building

- Original chimney cap and upper chimney portion missing

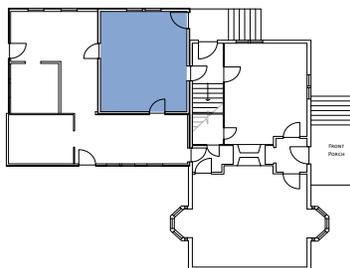
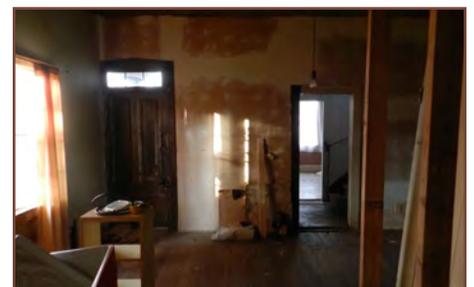
- Front door appears to not be operational due to hinges missing hinge bolt
- Previous water infiltration at ceiling, some passing through chimney to ceiling as there is no cap on the chimney
- Extensive wear at wood flooring
- Ceiling framing stressed below attic chimney due in part to chimney mass and deterioration of wood members due to water infiltration through chimney

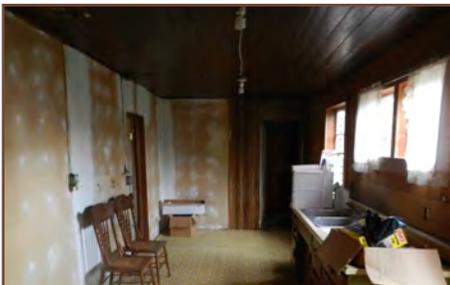
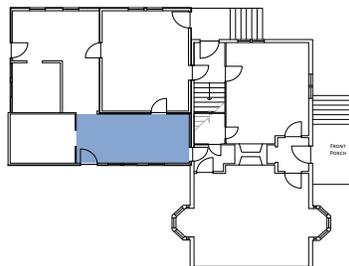
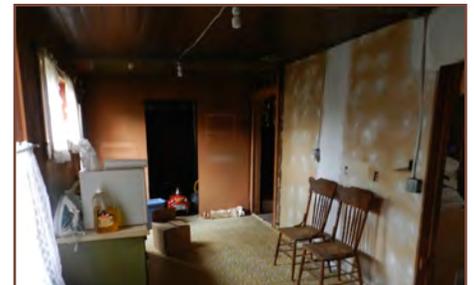
- East door hinges and knob were previously on the opposite side of the door; former holes remain at these locations.
- North door, extensive damage to stile from dog claws

- Sheet vinyl added over wood flooring
- Built in cabinets, sink, and counter along east side
- Hooks added in ceiling
- Added paneling at north end
- Sheetrock added on west wall
- North doorway to the 1866 Haller addition cut through vertical plank walls with new header, while sides of frame appear to be original to the door installation; threshold is not original

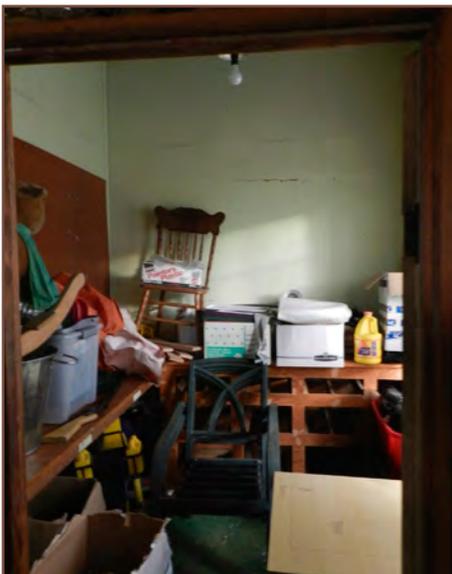
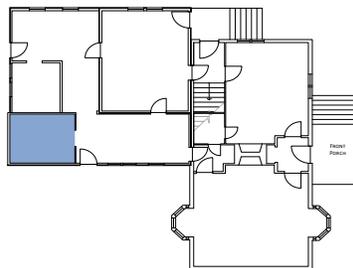
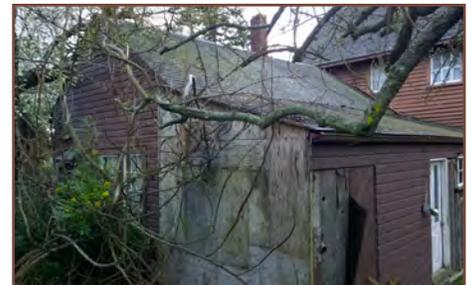
- Overall poor condition

- Added vinyl flooring
- Added two by four framed south and west walls
- New light fixture, wiring, and dryer connection
- Added ceiling framing and sheetrock
- Removal of the south extension prior to 1909

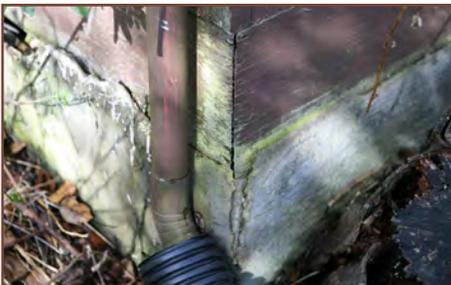
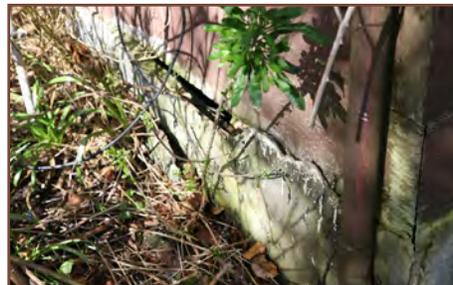
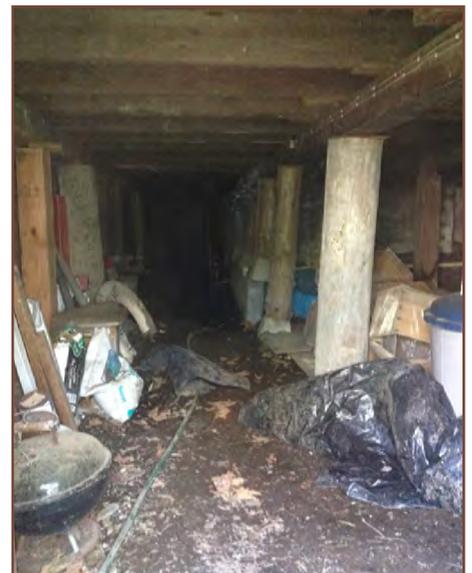
- Pre-cast concrete footings below
- Plumbing runs through the foundation crawl space
- Added cementitious skirting around the east and north side to the east of the porch, and on the east side of the house. The west side and remainder of north side are plywood skirting.

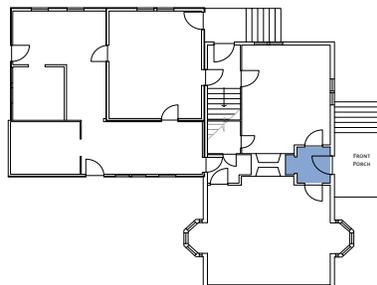
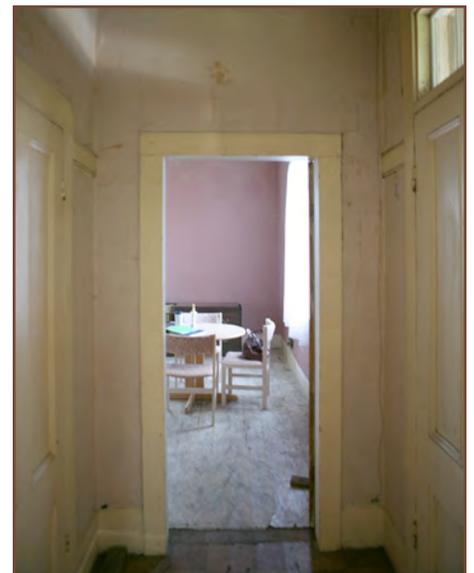
- Damaged plaster
- Missing sections of lath on north wall
- Missing plaster on ceiling and sections of lath walls
- Fire damage evident in the entry closet at the main chimney including charring and smoke damage

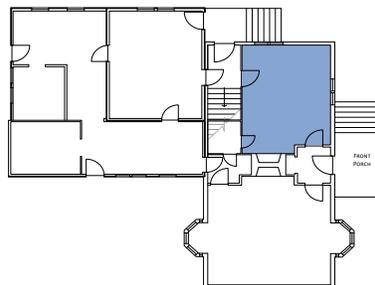
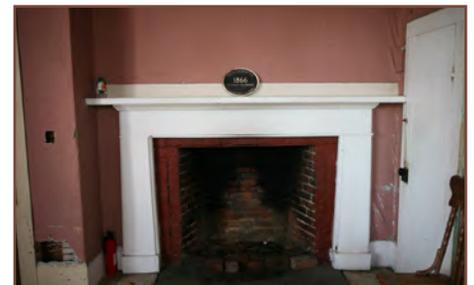
- Plaster and wallpaper over fireplace buckling
- Water infiltration at chimney, causing plaster above the fireplace to buckle and creating dampness at the hearth
- Holes in lath and plaster throughout room

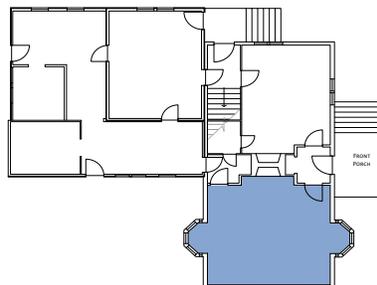
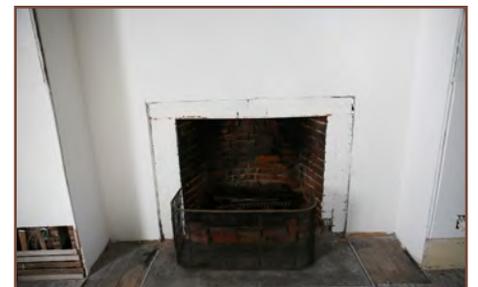
- Broken and cracked window glazing
- Names of two Willhight family members etched in one pane of the north bay window
- Holes in plaster and lath for electrical wiring
- Fire damage to floor joists on floor above and at exposed second floor joist at west wall
- Buckling wood floor beneath the linoleum and substantial slope to floor, high in center of room with slope to north and substantial slope to south
- Cracked plaster at bay windows and substantial deterioration at south bay window
- Baseboards around south bay window separating at miter

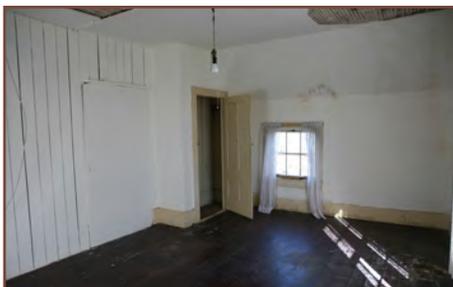
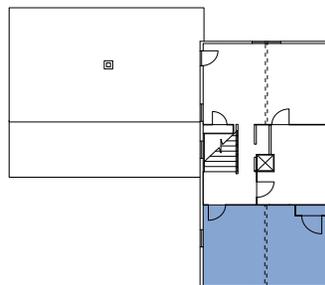
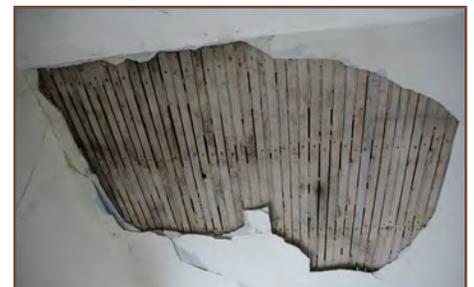
- Cracked and damaged plaster on walls and ceiling
- Mold growing on plaster on east wall and ceiling lath
- Damage to baseboard beneath east wall mullion where former partition wall removed

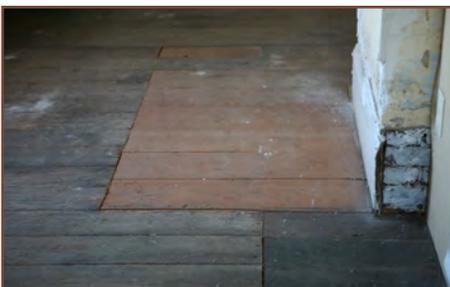
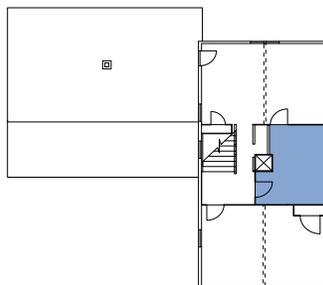
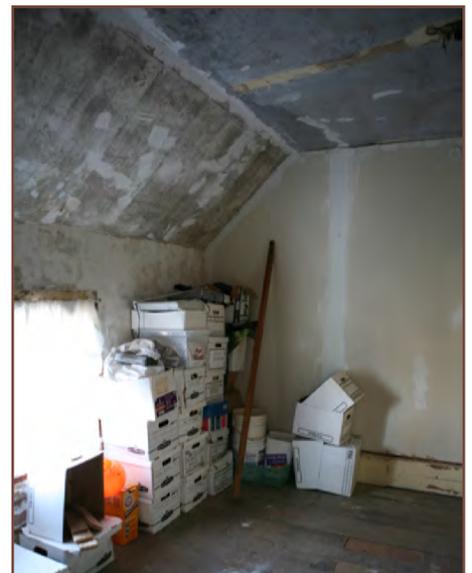
- Damaged plaster walls
- Missing pieces of baseboard

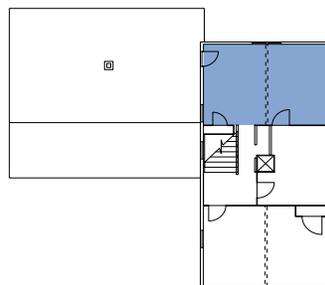
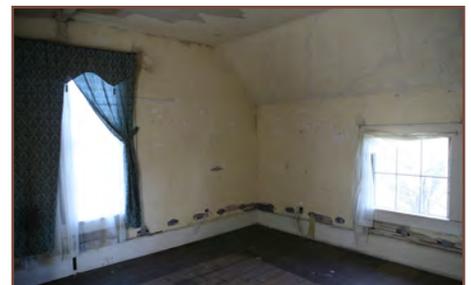
- Damaged and cracked plaster walls and ceiling
- Holes in lath and plaster throughout room
- Water damage evident on paper covering ceiling
- Baseboard notched below mullion of west wall window, evidence of previous room partition

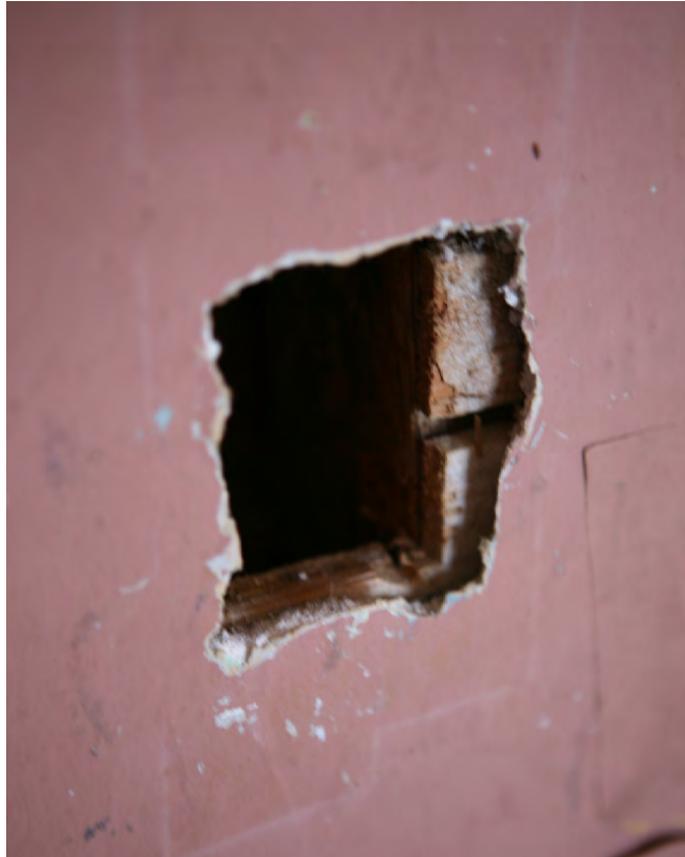
CP 6. Hole cut for outlet. Source: Artifacts Consulting, Inc.
